ស្រៃ WHITE PAPER — Si124 Acoustic imaging

HOW TO DETECT COMPRESSED AIR LEAKS **FASTER WITH ACOUSTIC IMAGING**

REDUCE INSPECTION TIME BY UP TO 90%

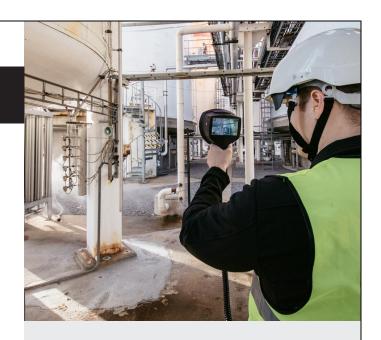
The FLIR Si124 is ideal for pinpointing leaks in complicated, difficult-to-access locations
